Shore parallel pile row breakwaters, an example of an effective coastal protection scheme

ir. J.S. Reedijk, senior coastal engineer and drs P. Boswinkel, coastal engineer.
Delta Marine Consultants bv. Gouda, The Netherlands.

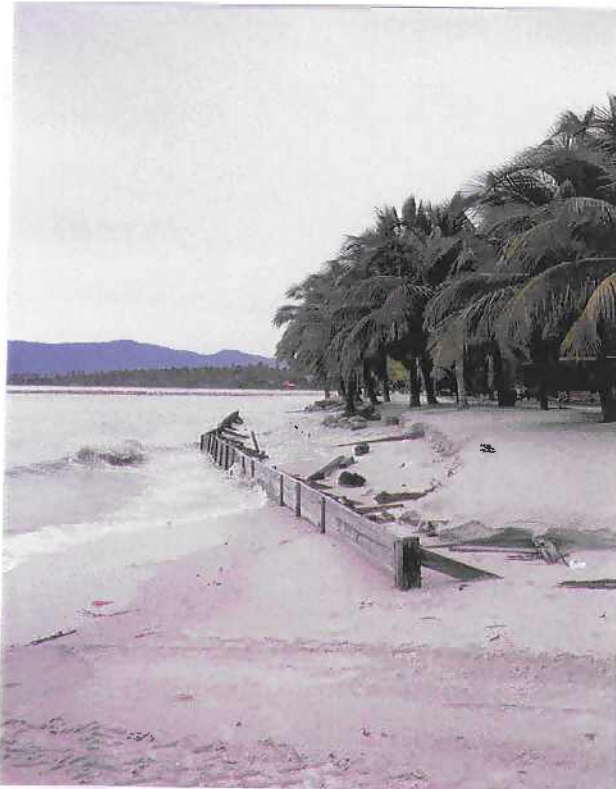
Before the Client contacted Delta Marine Consultants several measures had been tried to halt the erosion, none of them were successful. First interlocking concrete blocks were put on the beach, but these disappeared below the sand after a storm. The remaining blocks are now in use as pavement for footpaths. Then wooden walls were applied, but these were overtopped and undermined. Finally sand bags and rock were put on the beach, providing an unsightly view. After each storm new sand bags had to be placed, and the beach had to be reshaped with bulldozers. This was not the favourite task of the sports department. Some of the failed measures are shown in the photographs.

Photograph 1. Failed wooden wall

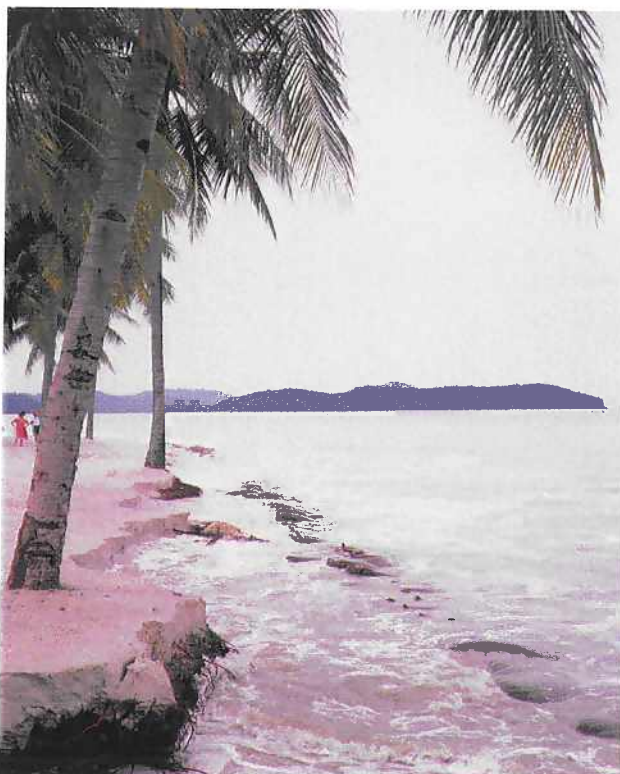
Photograph 2. Sand bag protection

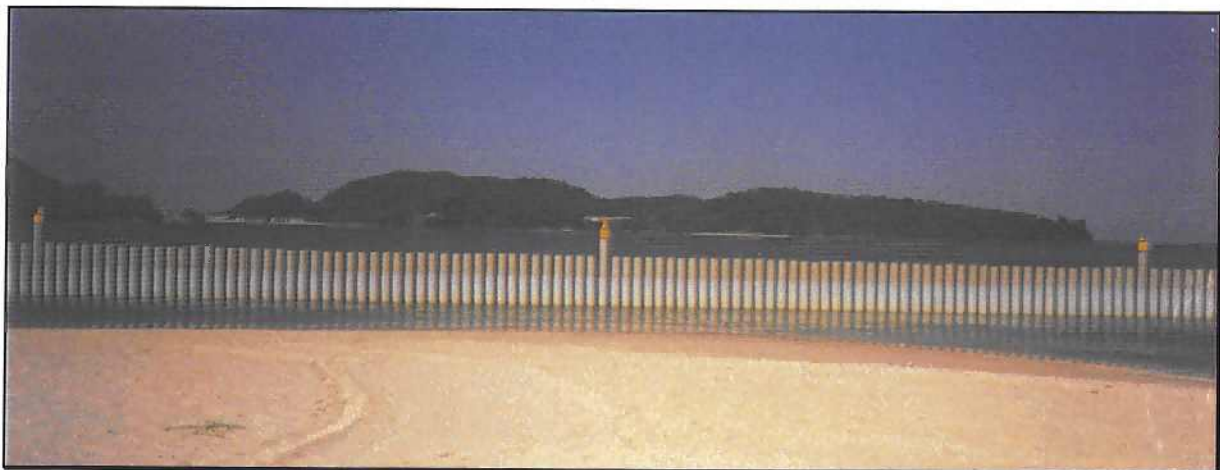
Photograph 3. Pile row at low water level

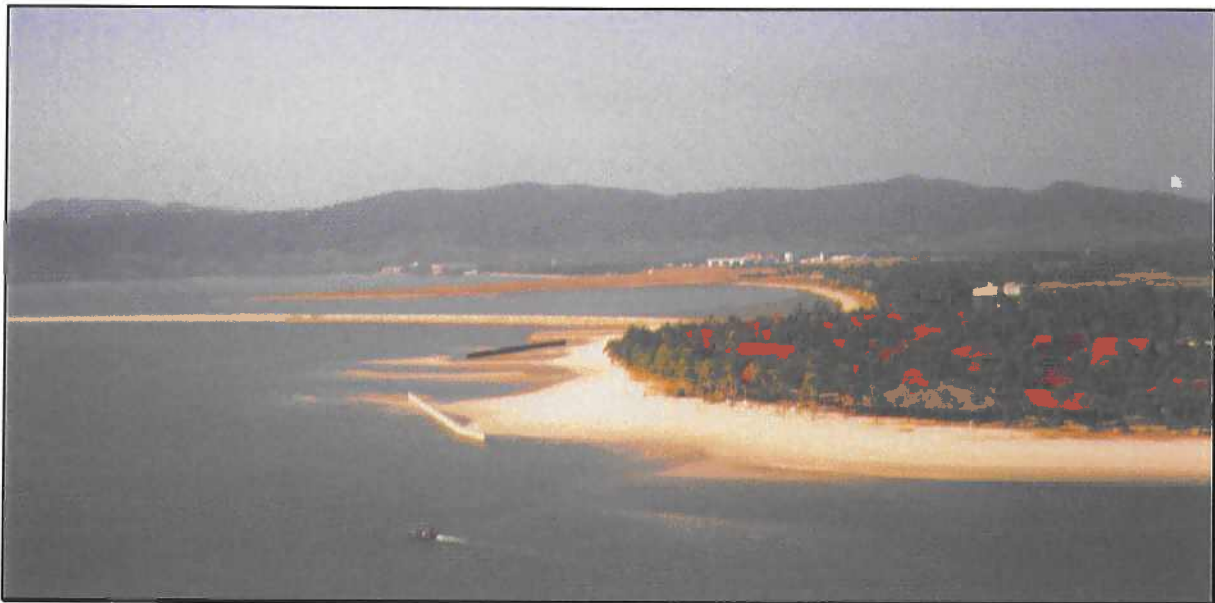
Photograph 4. Overview of the beach resort with pile rows.

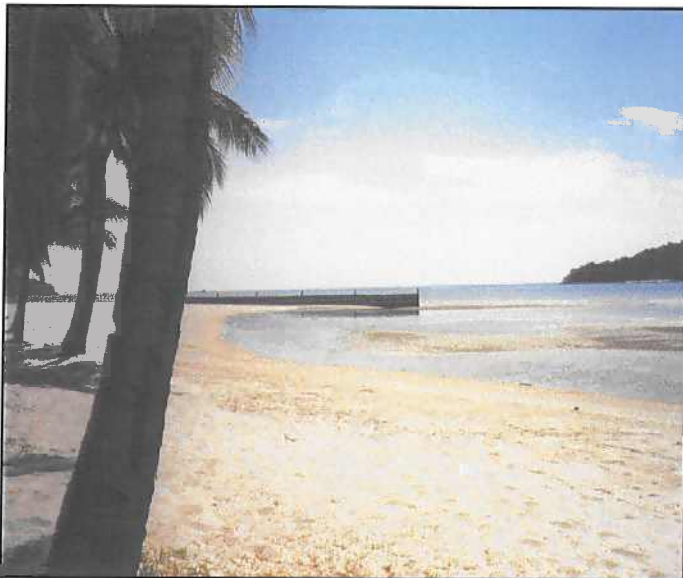
In February 1998, one year and four months after construction, a follow up visit was carried out. At the moment of arrival the promising results of the pile rows were obvious: the beach has restored completely in the lee of both pile rows. Although no replenishment was carried out after construction, the coastline has developed seaward over the full length of the beach at the resort. The situation during this visit was fully satisfactory for the client, except for some corrosion problems of the steel pile caps [which were not immediately coated after construction].

In general the pile rows performed excellent. The salient sand bodies on the lee side of the pile rows almost developed into shore connecting tombolos. The volume of sand trapped behind the pile row is more than was expected. Since the Client did not carry out the designed beach replenishment, the material trapped behind the structures was eroded from neighbouring beaches. As a consequence of this, the beach between the two pile rows and south of the structures has eroded to some extent.

Photograph 5. Southern pile row at low tide

Minor erosion around the piles can be observed. The scour along the pile rows is generally less than one pile diameter. The open structure also allows cross shore transport to propagate through the pile rows. This is illustrated clearly by small sand bars which develop through the pile rows, continuing on both the exposed and lee side of the piles.

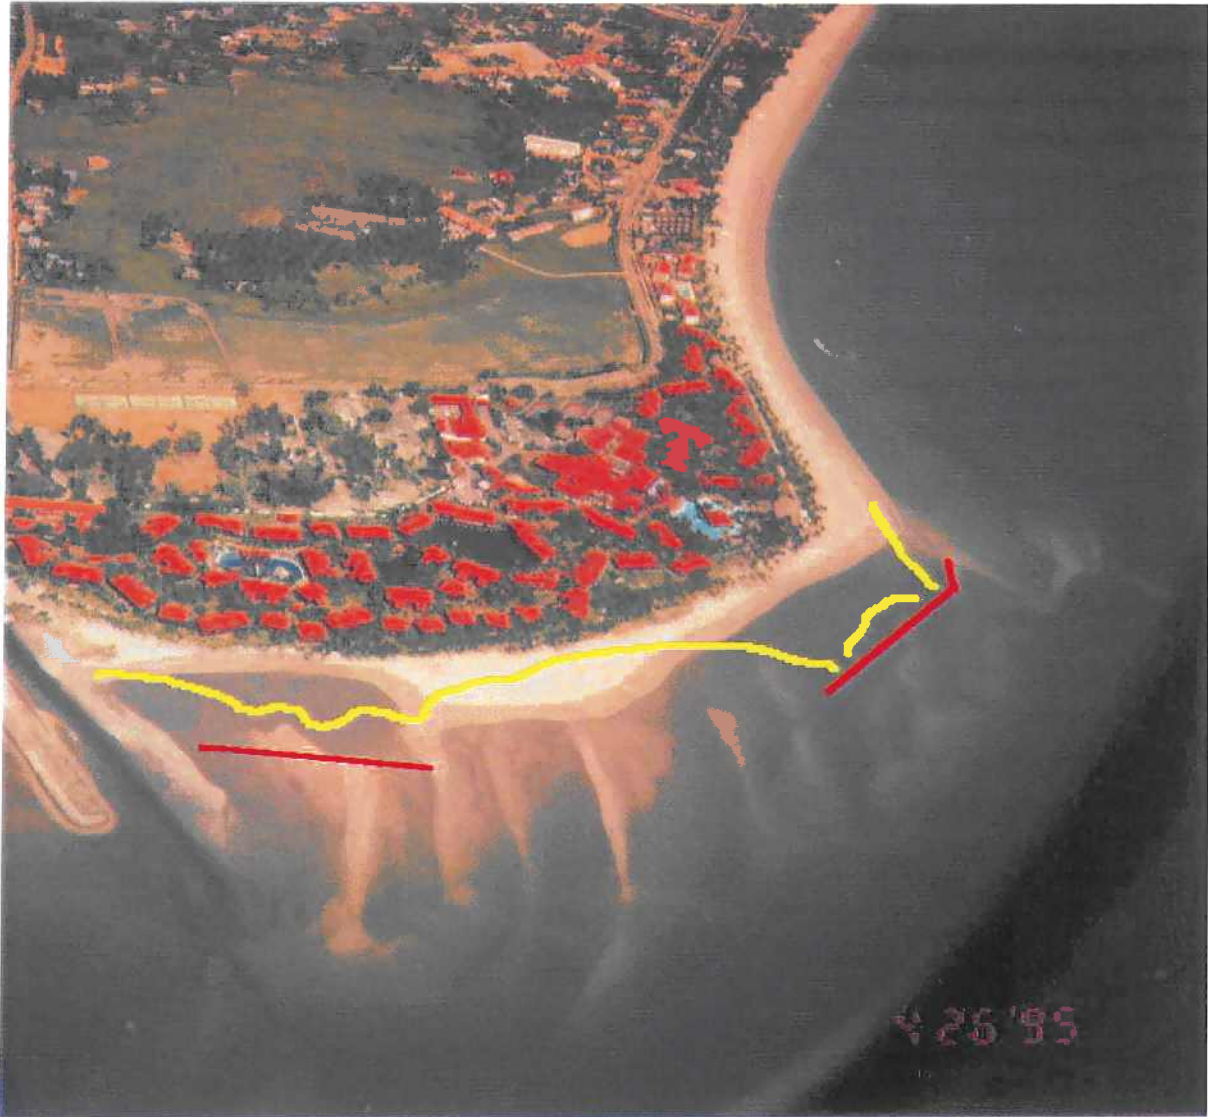
In photograph 6 the situation is shown before the pile rows were built. The location of the pile rows and the present shape of the beach is also indicated. It clearly shows the positive effect of the pile rows on the beach. After construction of the pile rows no more maintenance of the beach has been required.

Photograph 6. *Situation before and after construction of pile rows*
